Manhole Inspection Summary

Manhole # S37YY_002MH

Location Address: **3211 GREENMOUNT AVE** Cross Street: **GORSUCH AVE**

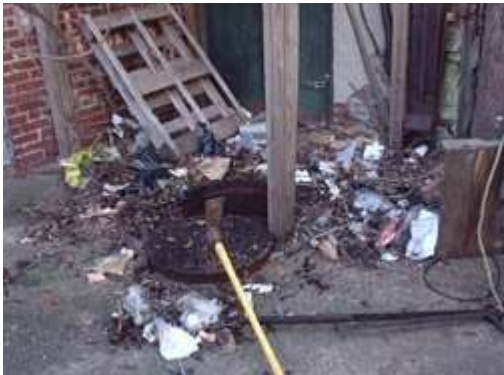
Location View

DEBRIS COVERING MANHOLE LID

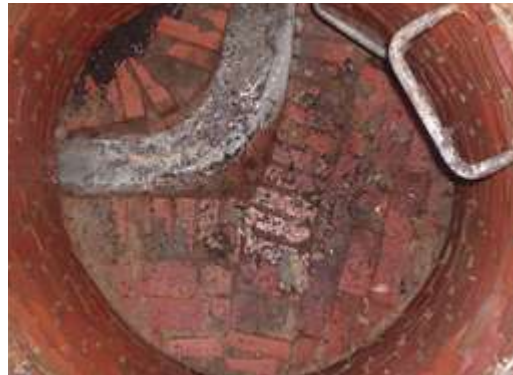
Top View

Bench ☒ Exists Material: **Brick** ☐ Parged ☒ **Debris** (not Condition related)
Condition: ☒ Sound ☐ Cracked ☐ Root Intrusion ☐ Deteriorated ☐ Leaks ☐ Debris

Channel Material: **Brick** ☐ Parged ☒ **Debris** (not Condition related)
Channel Exposure: **Fully Open** Junc Dist: **0.5** nearest .5 ft. Azimuth: **-1**
Condition: ☒ Sound ☐ Cracked ☐ Root Intrusion ☐ Deteriorated ☐ Leaks ☐ Debris

Bench and Channel debris.

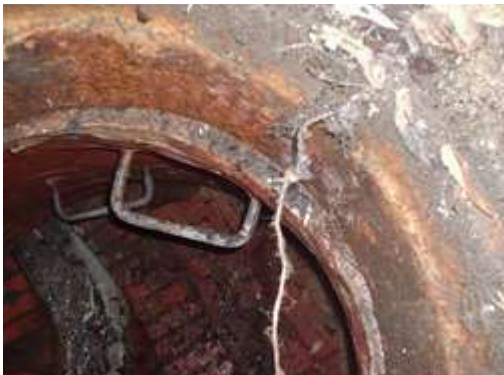
Defect

Frame Offset: **1** (in.) Condition: ☐ Sound ☐ Cracked ☒ **Leaks**

Chimney / Frame Adjustment ☒ Exists Material: **Brick** ☐ Parged Height: **6** (in.)
Condition: ☐ Sound ☐ Cracked ☐ Root Intrusion ☐ Loose Brick ☒ **Deteriorated**
Infiltration: ☐ None ☒ **Joint** ☐ Cracks ☐ Mortar ☐ Roots ☒ **Wall**

Frame leaks. Frame offset. Adjustment deterioration and infiltration.

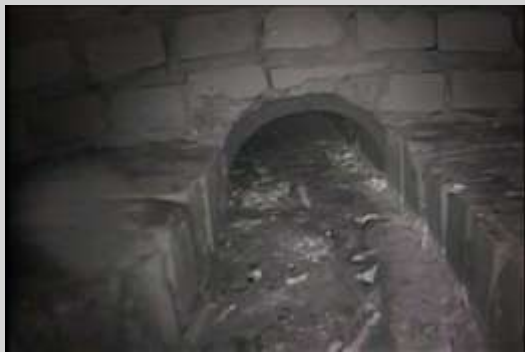
8 in. Circular Gravity Sewer Pipe Out @ 12 O'Clock

Deposits: ☐ None ☒ **Mud** ☐ Sludge ☒ **Debris** ☐ Grease

Silt Depth: **3** (in.) Deposits Extent: **Medium**

Infiltration: **Evidence** Pipe Seal Cond: **Unknown**

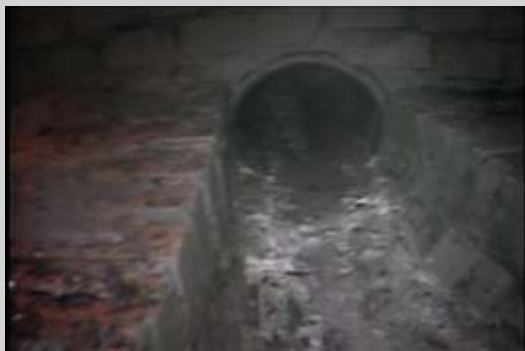
8 in. Circular Gravity Sewer Pipe In @ 9 O'Clock

Deposits: ☐ None ☒ **Mud** ☐ Sludge ☒ **Debris** ☒ **Grease**

Silt Depth: **0** (in.) Deposits Extent: **Light**

Infiltration: **Evidence** Pipe Seal Cond: **Unknown**
